BREEDS POND OUTLET DAM

MA 00238

PHASE I INSPECTION REPORT
NATIONAL DAM INSPECTION PROGRAM

AUGUST 1978

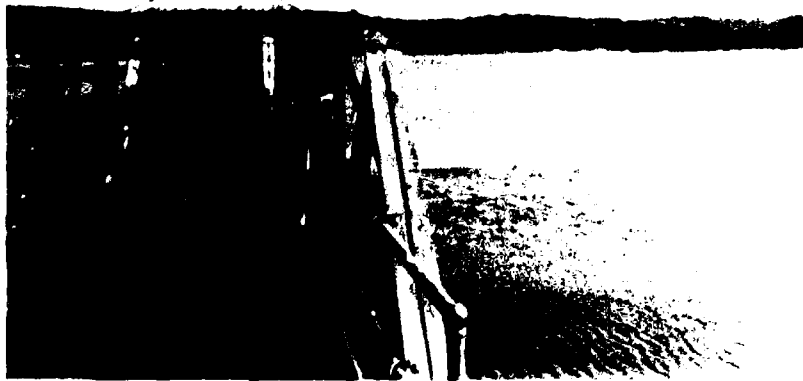
c. Appurtenant Structures. The concrete and brick gate house structure which discharges water to the Walnut Street pumping station is obviously operable and in apparent good condition. The steel service bridge, other than requiring painting, is also in good condition.

Bridge to Gatehouse
